# **FLOOD PLAIN MANAGEMENT**

**A Study Of South Fork  
Shenandoah Tributaries**

**Rockingham County, Virginia**

**CUB RUN – BIG RUN**

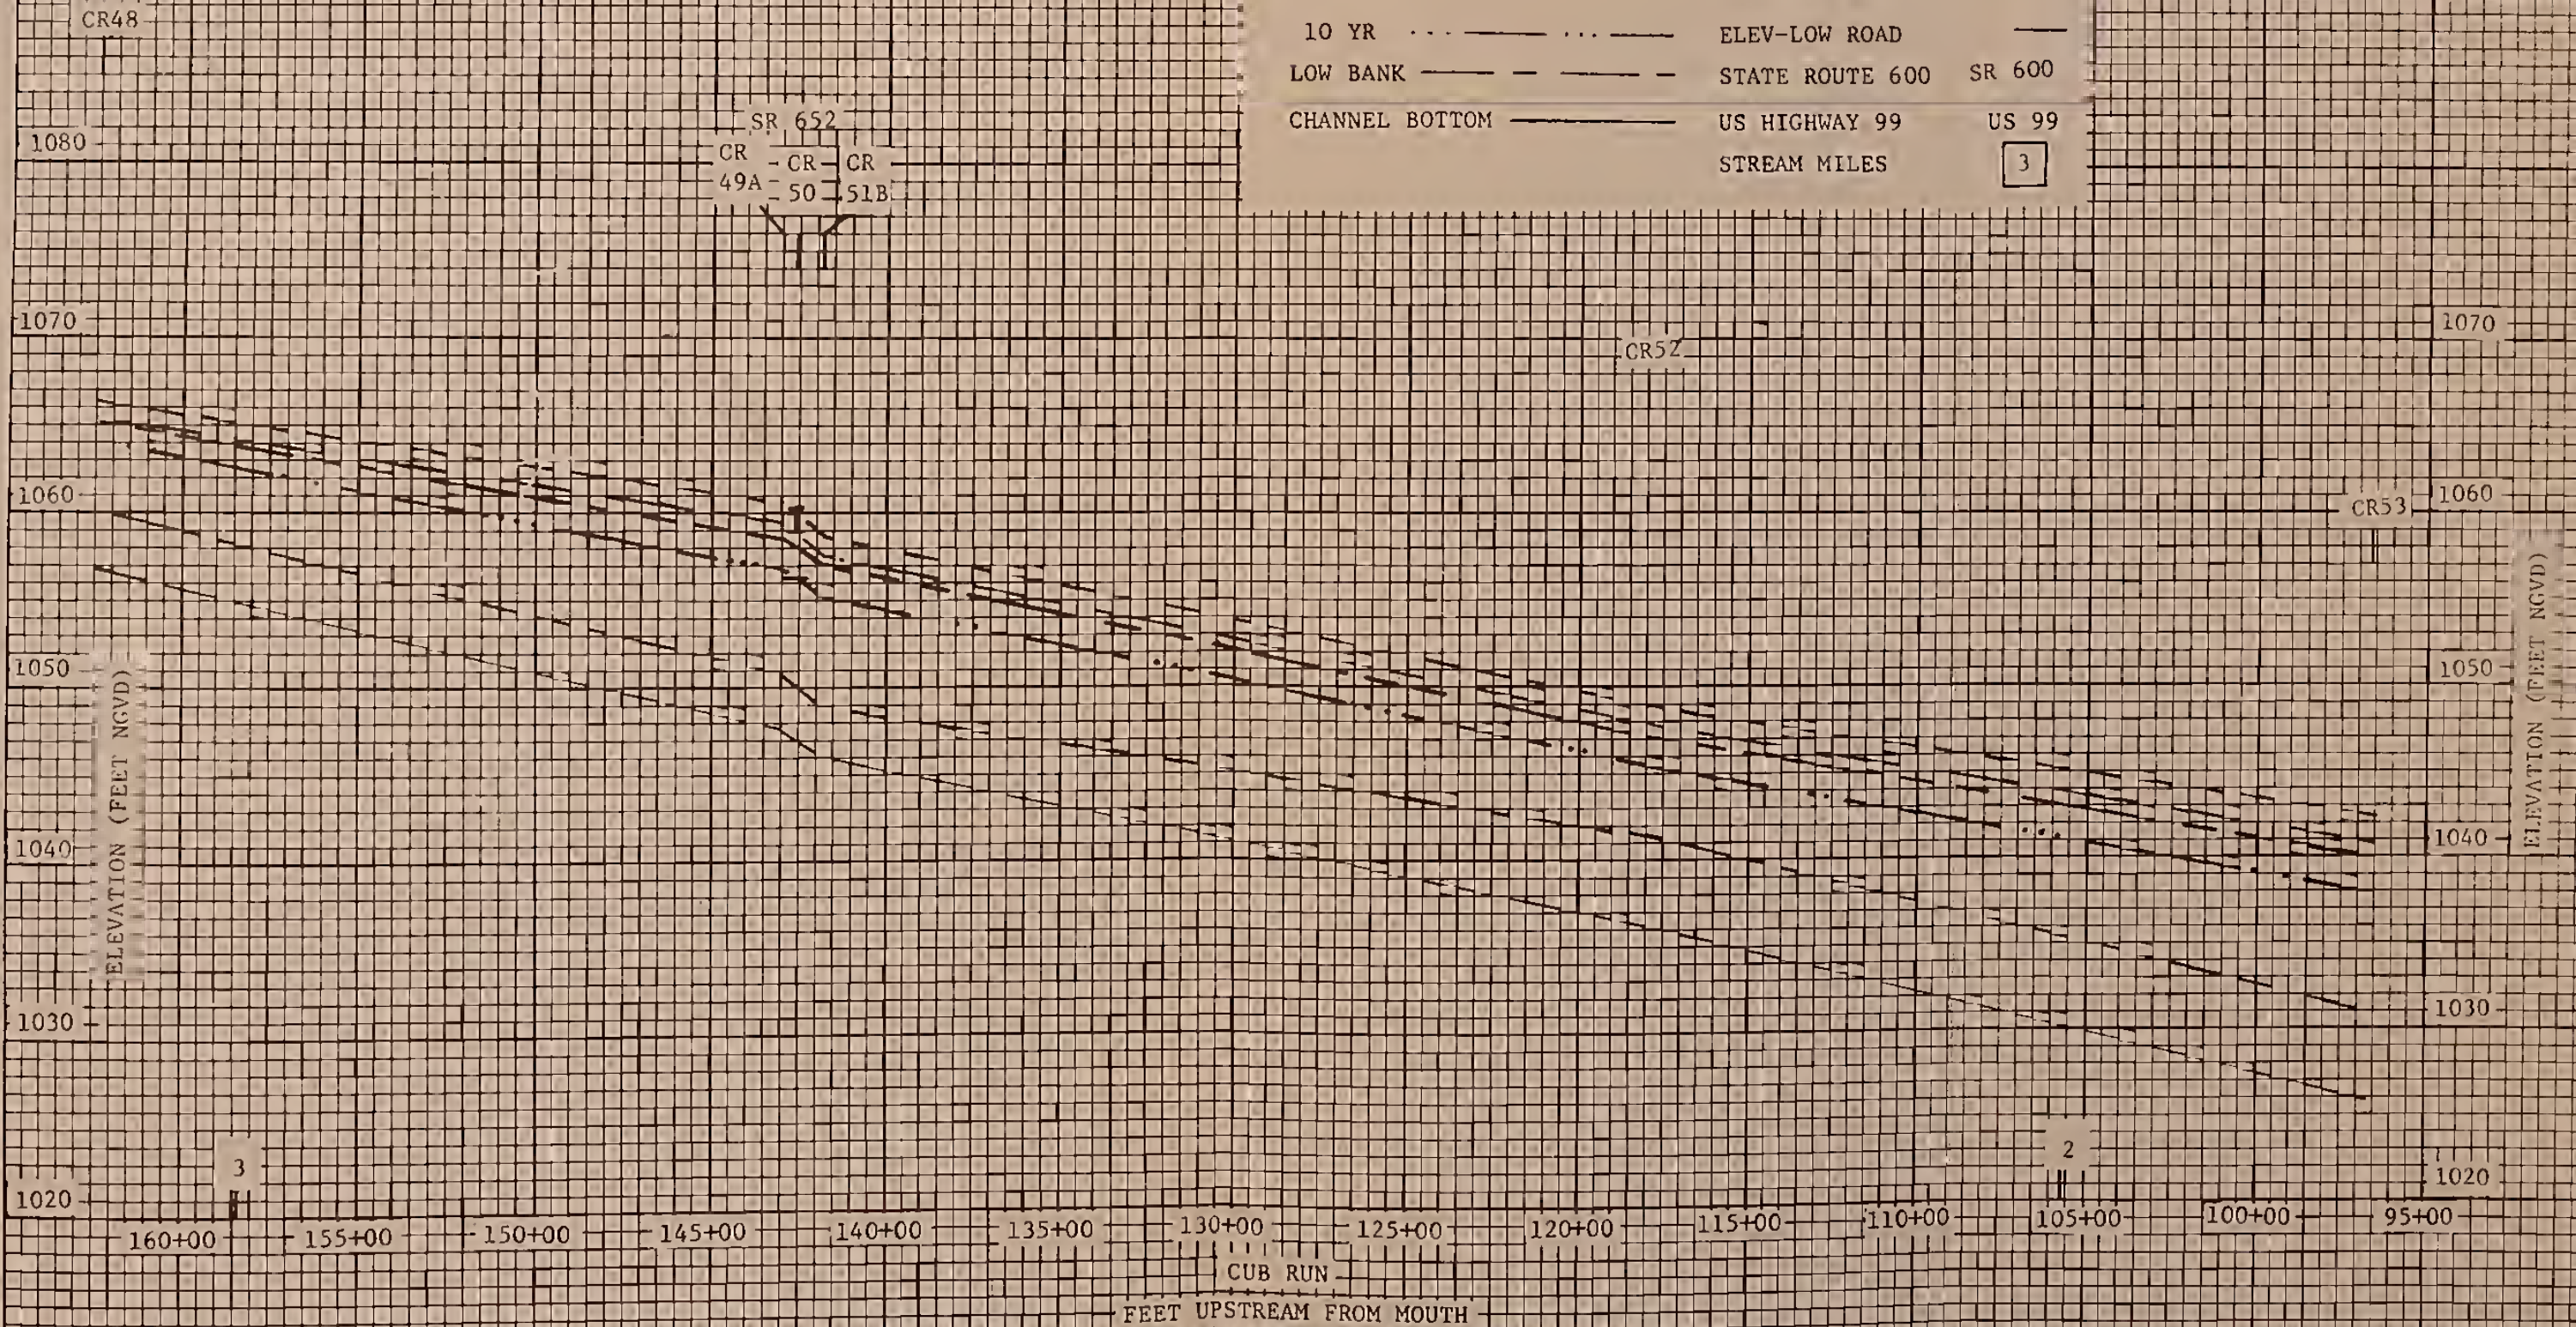
FLOOD PROFILES  
S FK SHENANDOAH RIVER TRIBS  
ROCKINGHAM COUNTY, VIRGINIA

Designed: MAM 11/79  
Drawn: MAM 11/79  
Traced: MAM 11/79  
Checked: MAM 11/79  
Date: 11/79  
PLATE 10 of 11  
CUB RUN - See  
Photomaps  
CR4 & CR5

Flood profile plates provide elevations of the 10, 50, 100 and 500-year floods at any location along the length of the streams. The elevations and discharges of the 10, 25, 50, 100 and 500-year flood at each surveyed cross section are given in Table CR-1. Sample cross sections illustrated how the flood area boundaries were located. Table CR-2 provides the description and elevation of benchmarks which are located on the photomaps.

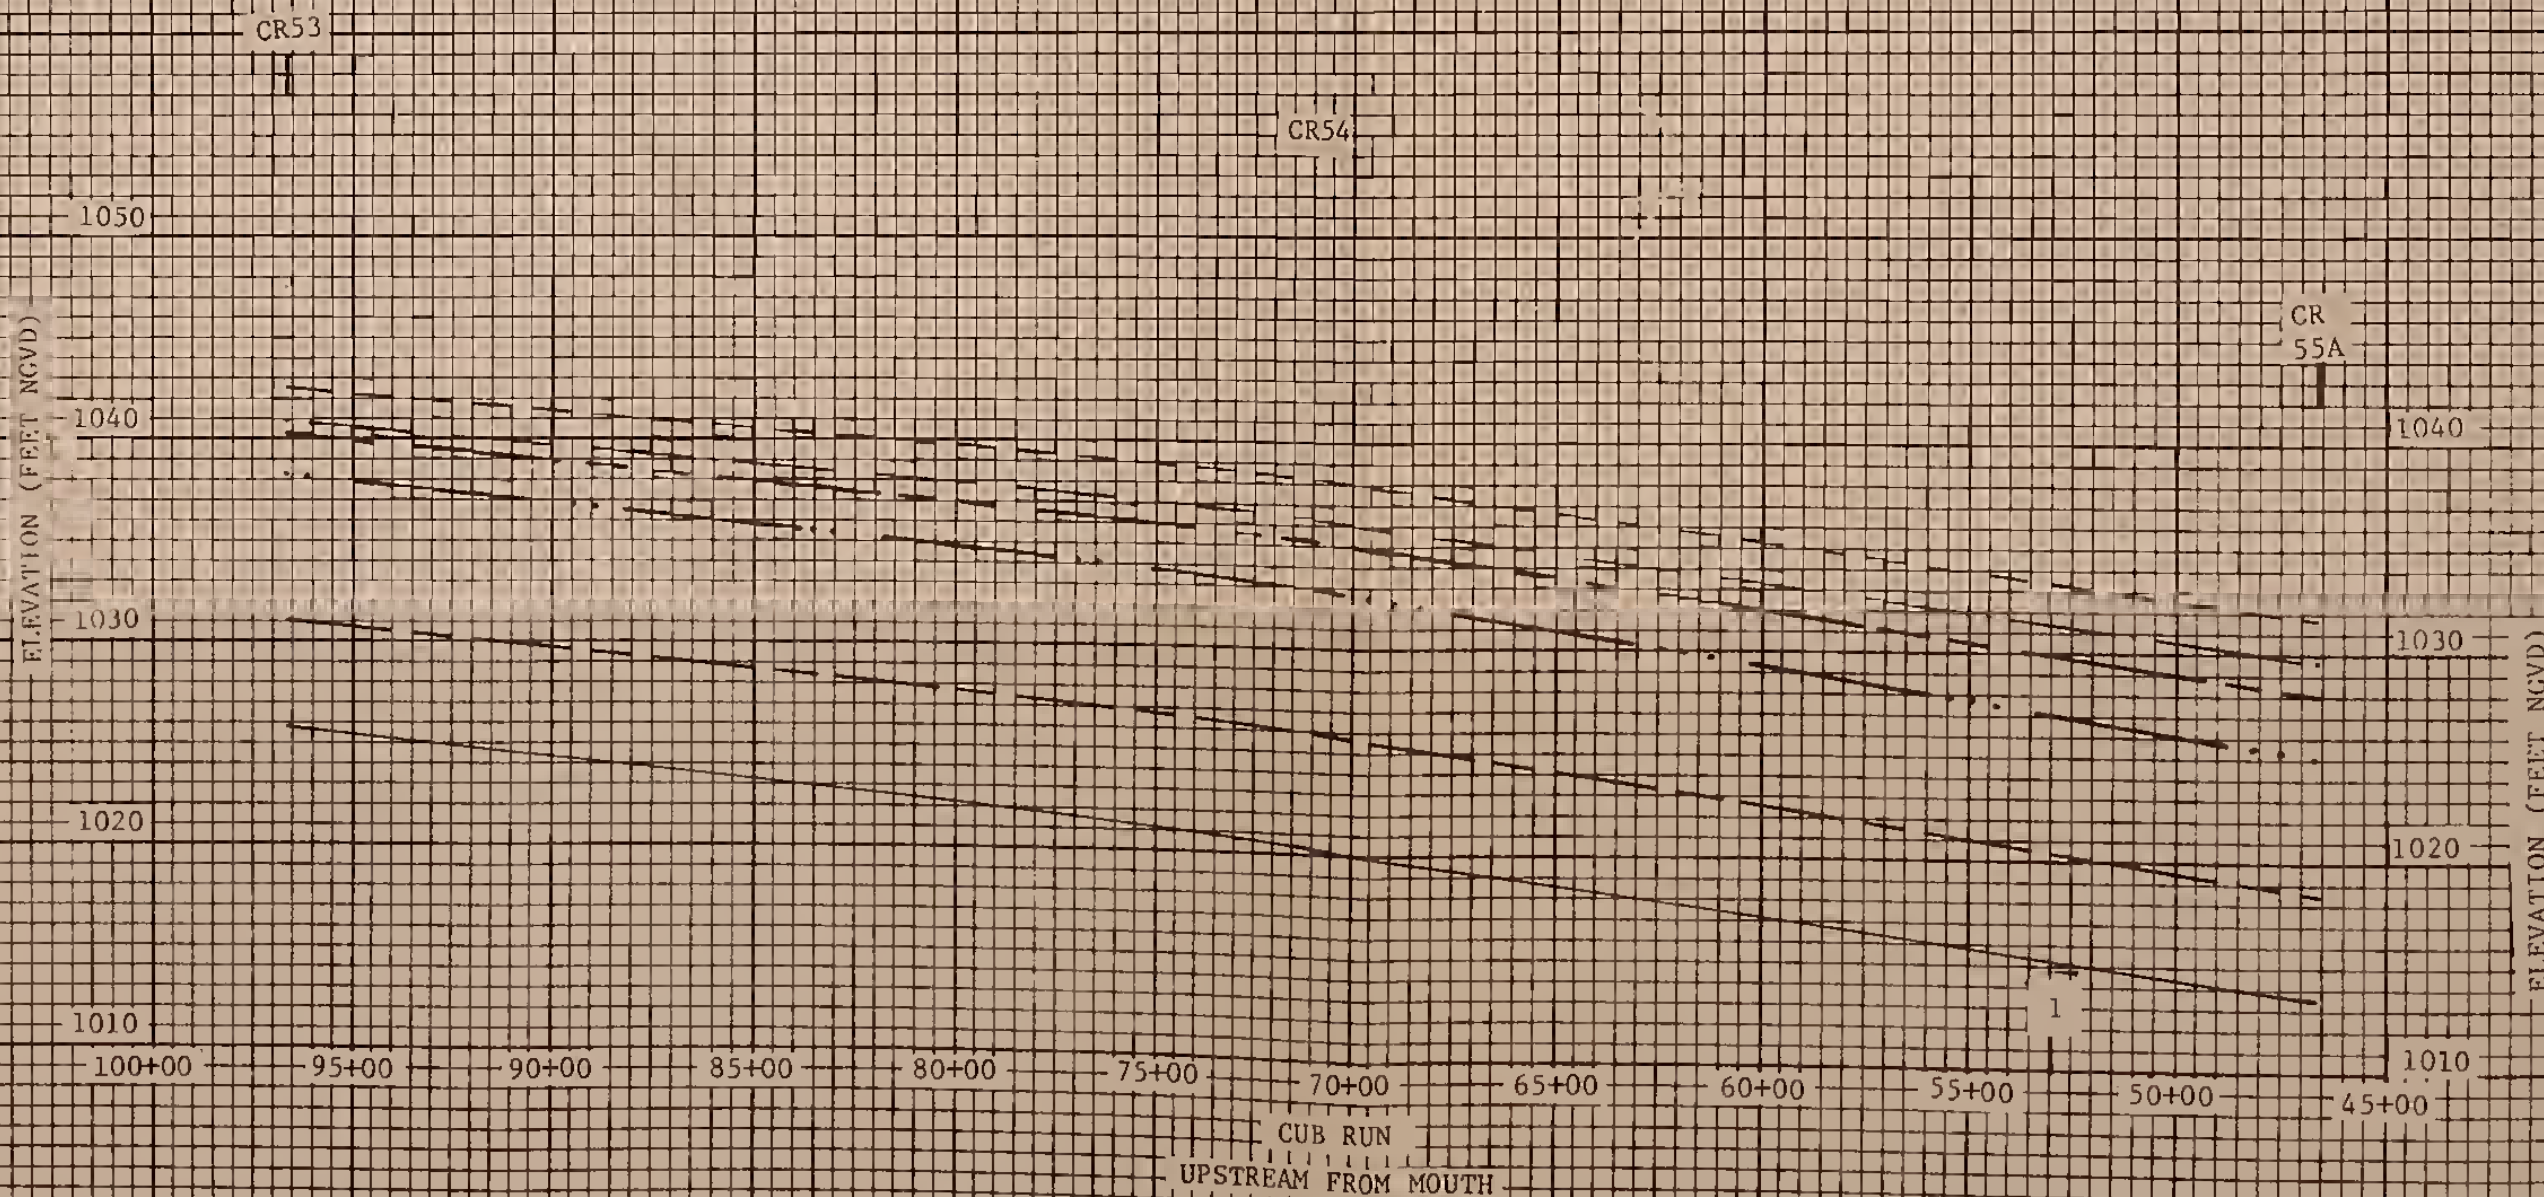
PLATE 11 of 11  
CUB RUN-See  
Photomap CR5

## FLOOD PROFILES

S FK SHENANDOAH RIVER TRIBS  
ROCKINGHAM COUNTY, VIRGINIA

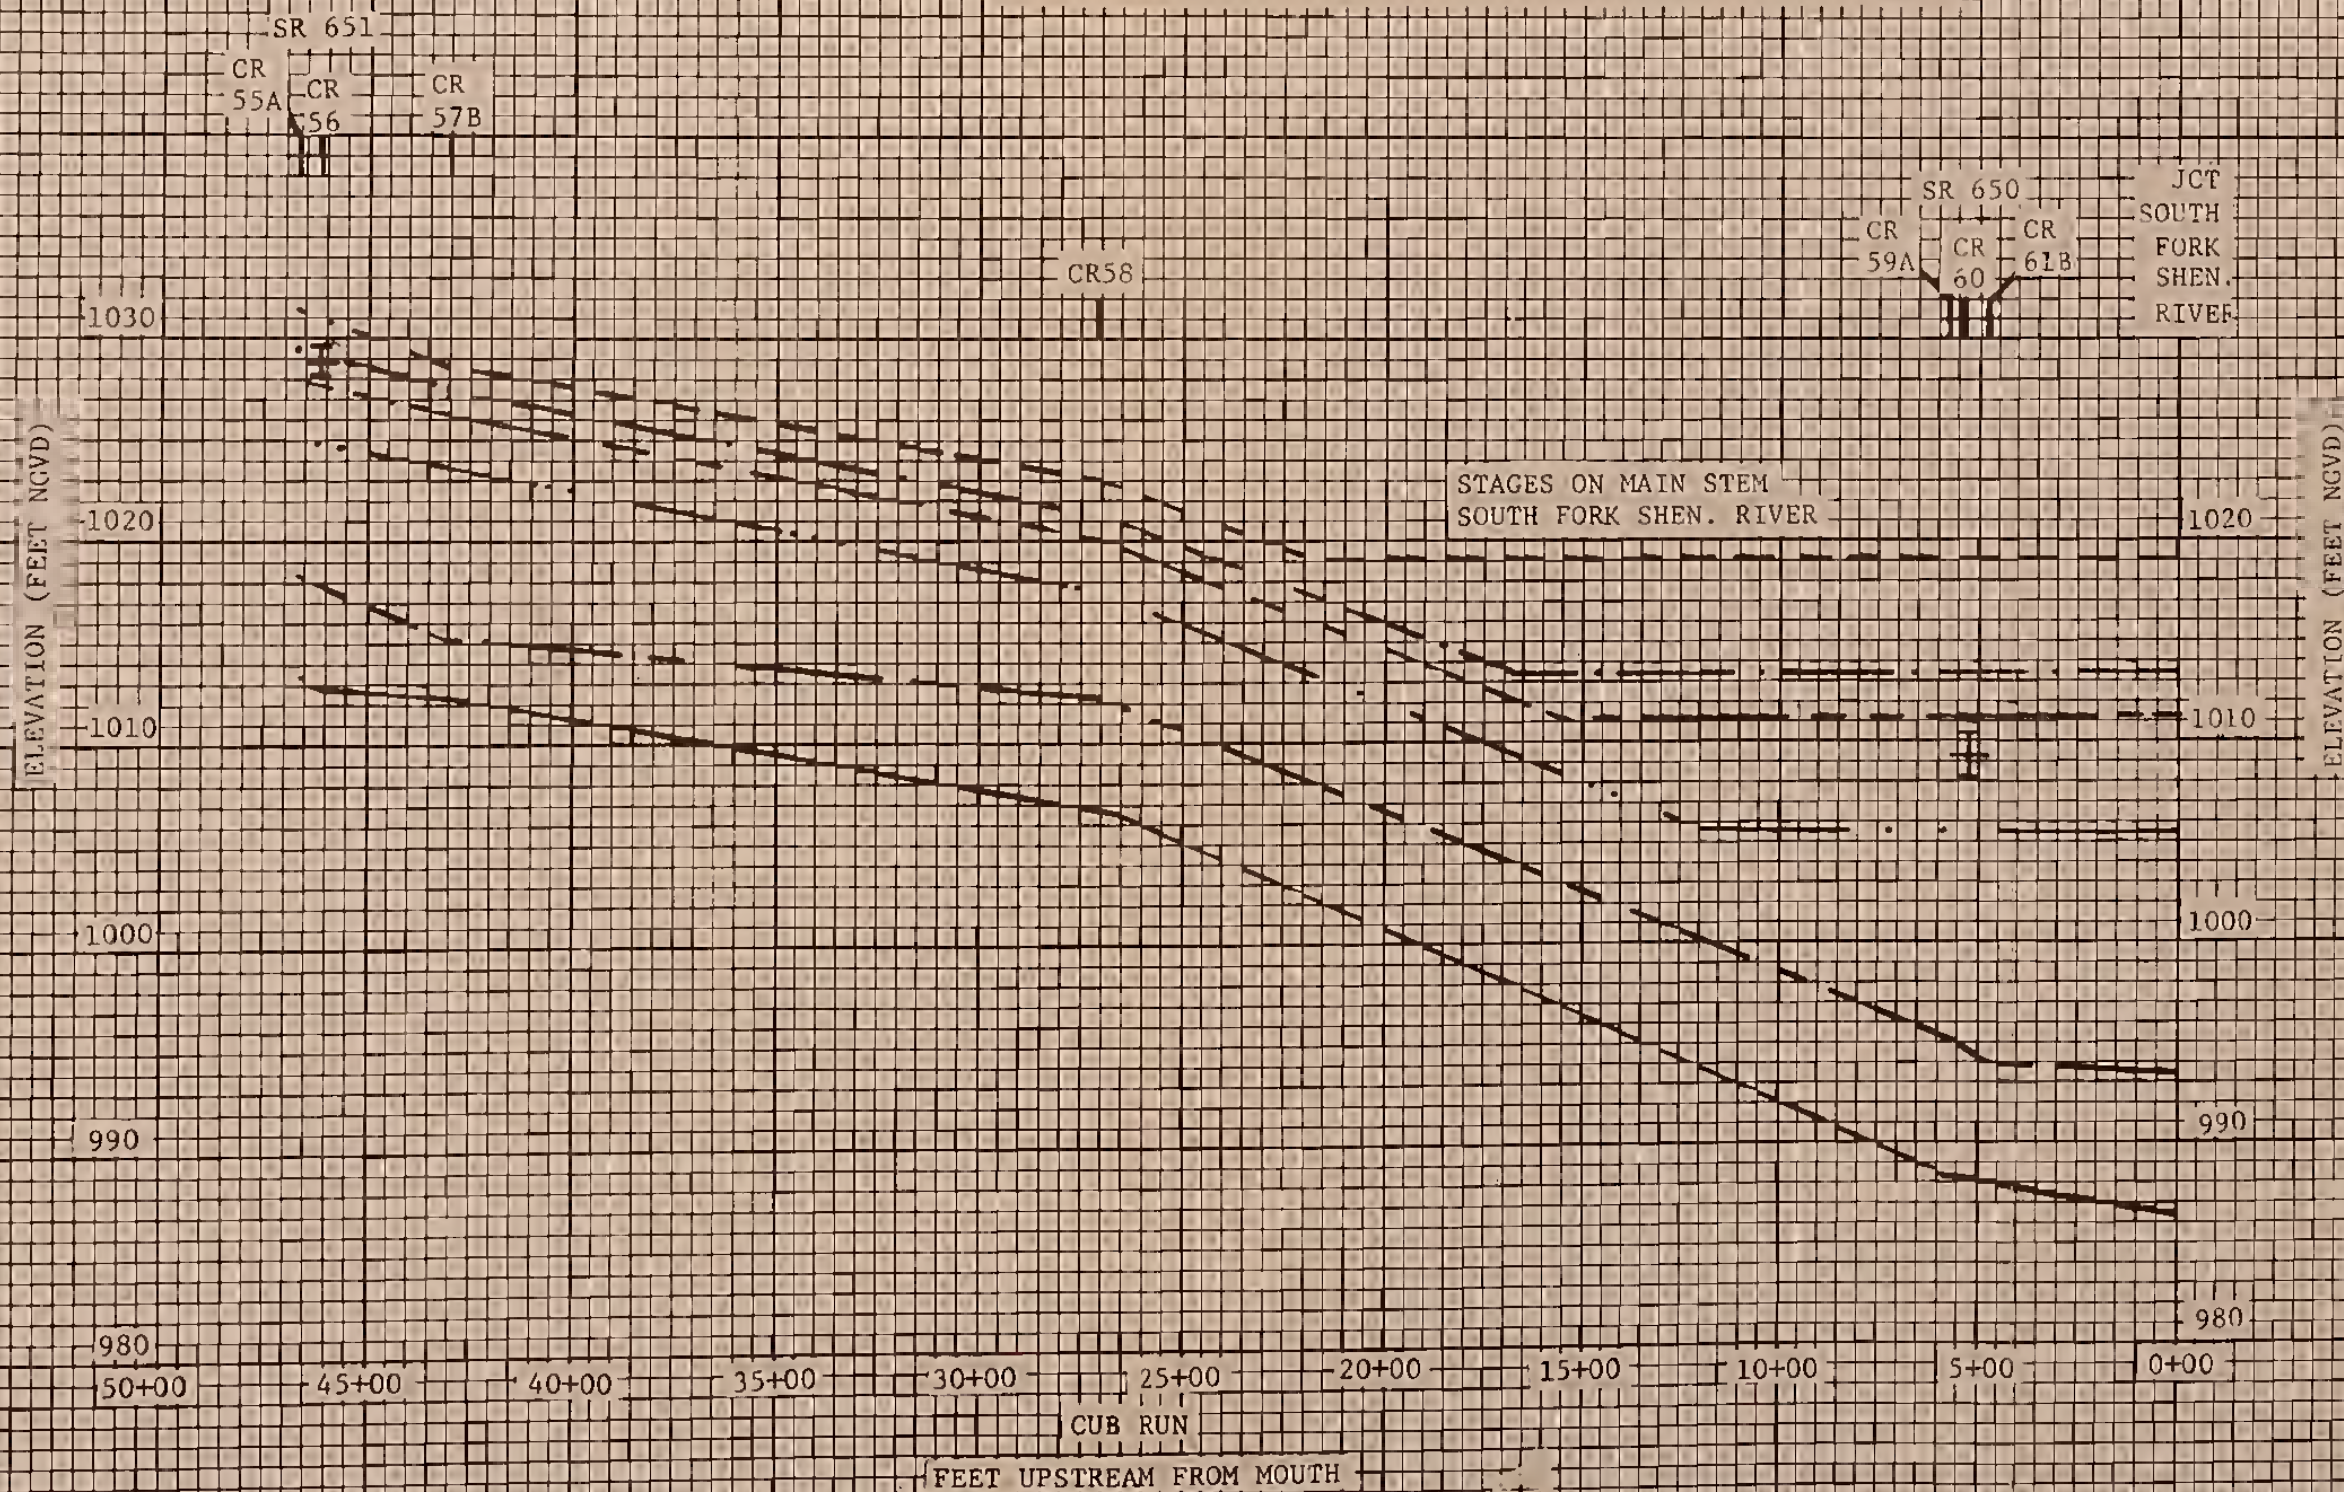
PLATE 1 of 2  
BIG RUN-See  
Photomap CR5

# FLOOD PROFILES S FK SHENANDOAH RIVER TRIBS ROCKINGHAM COUNTY, VIRGINIA

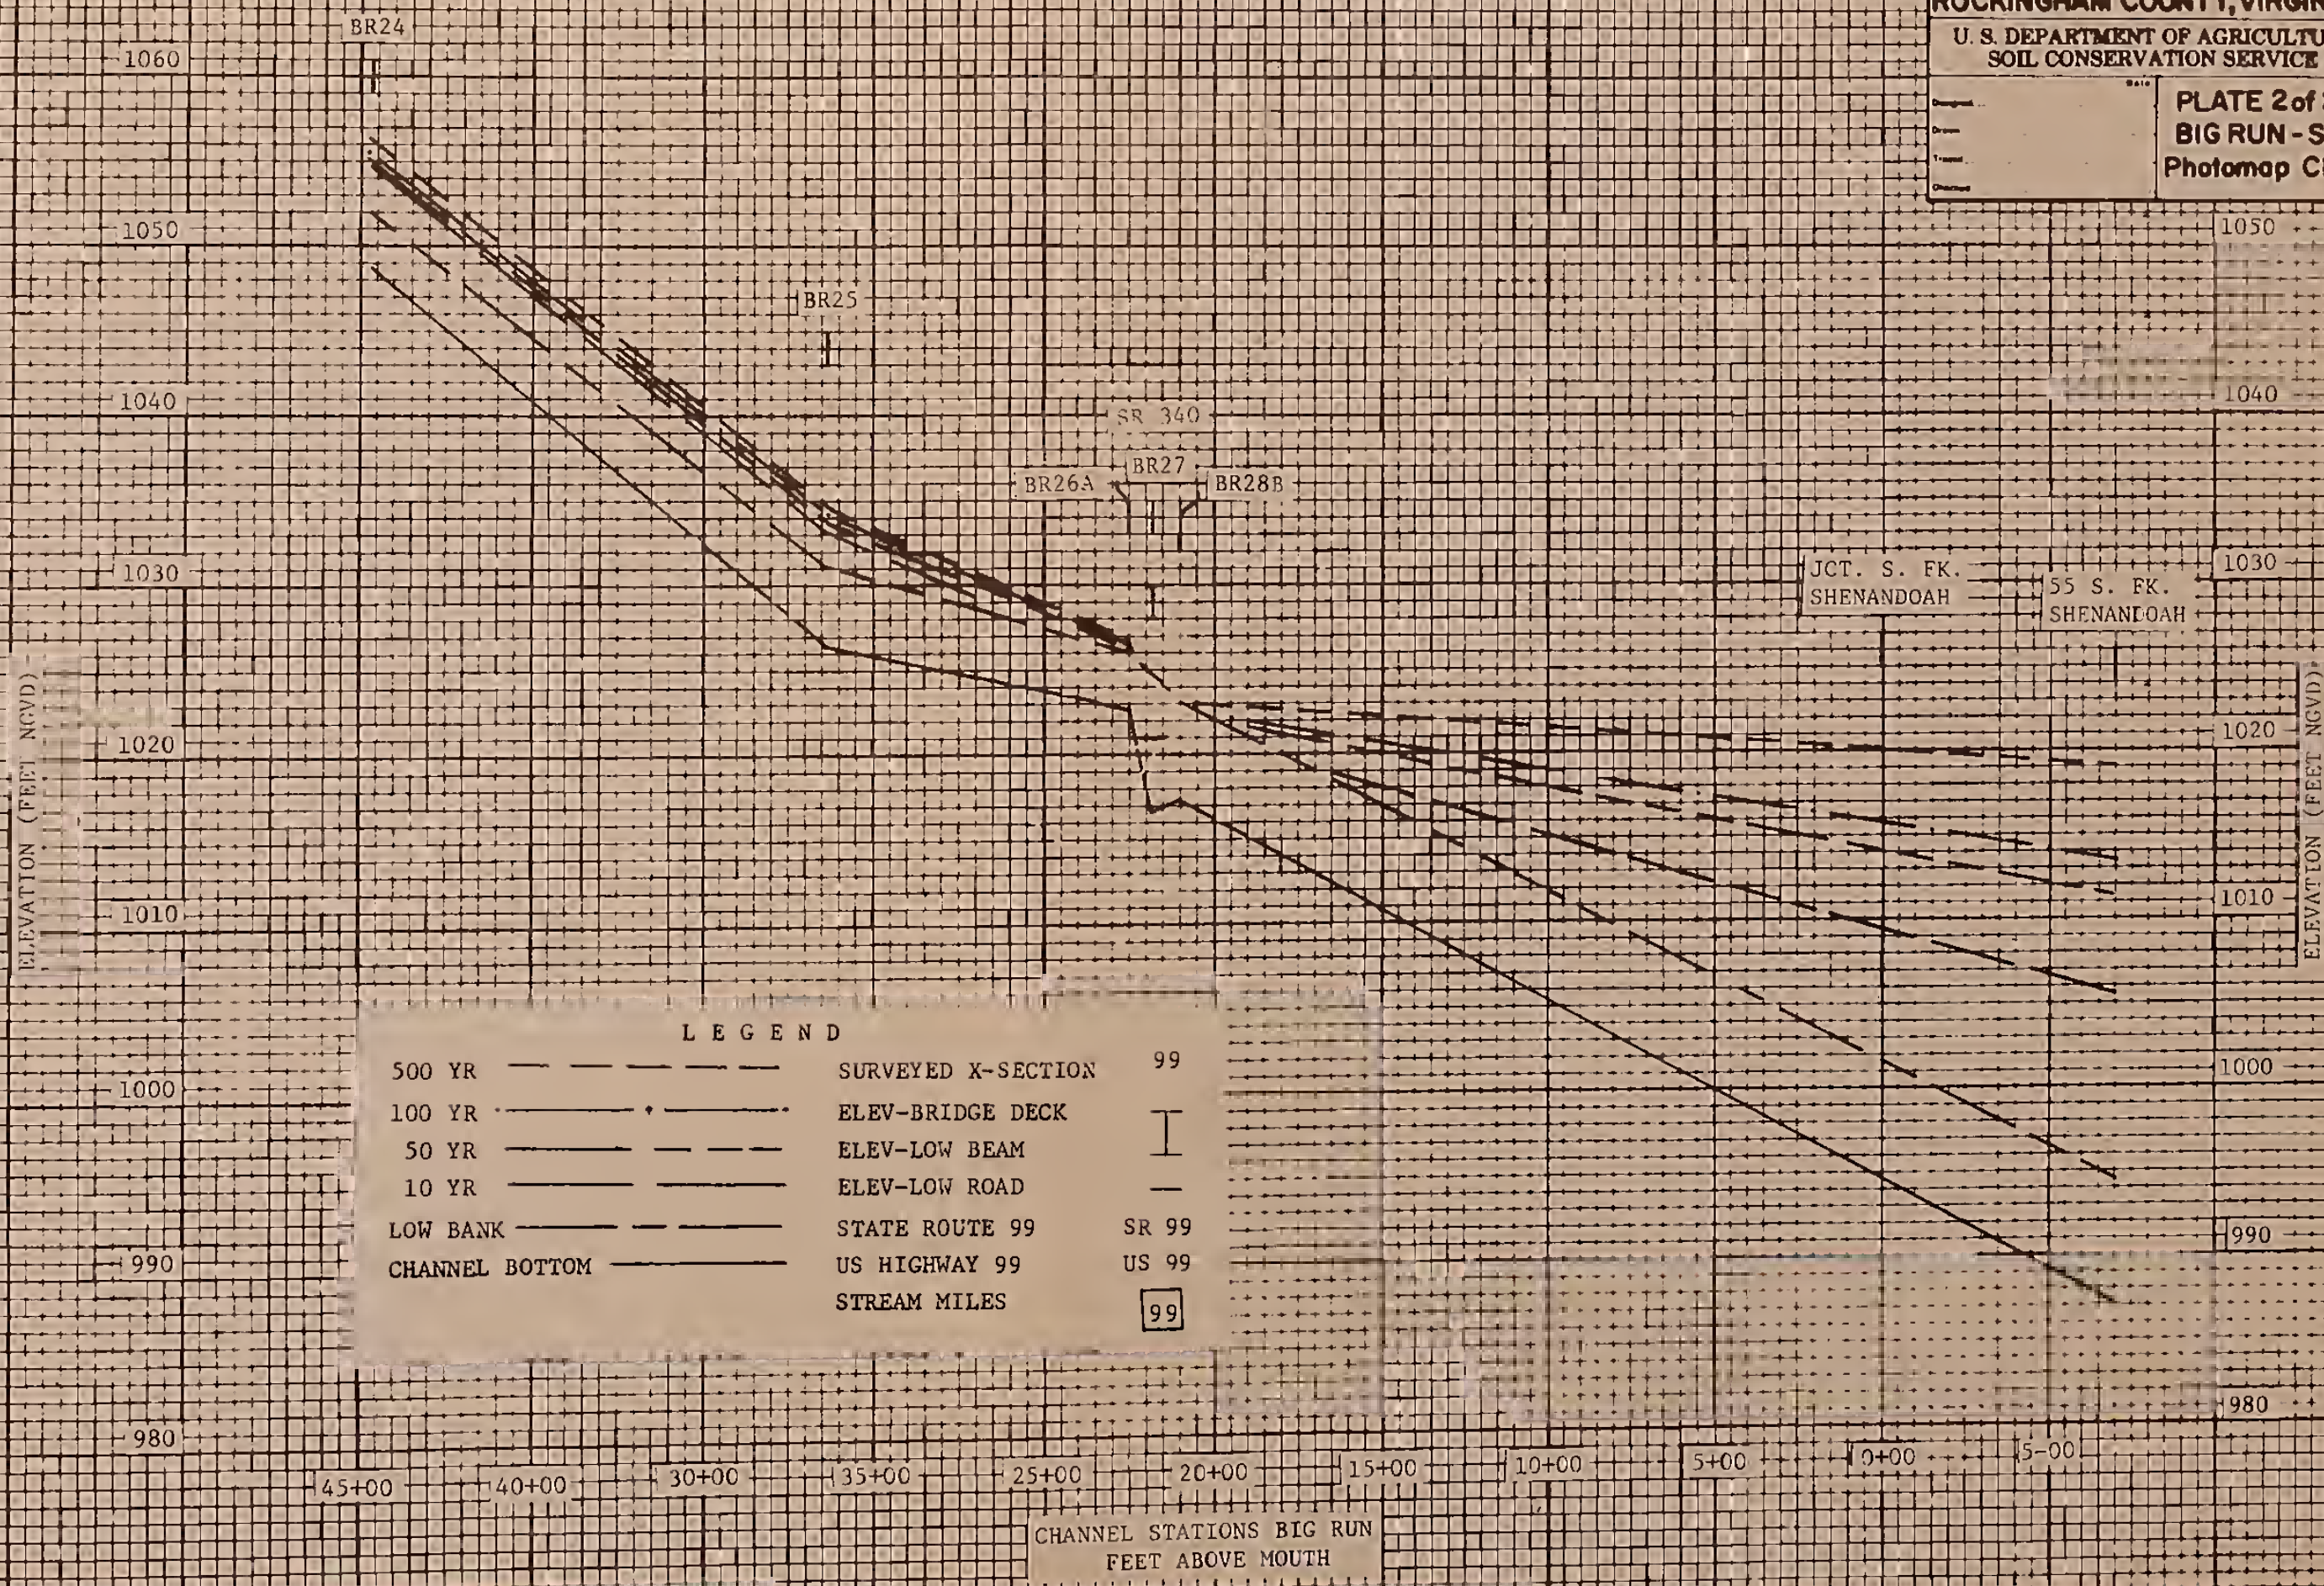
TYPICAL CROSS SECTIONS  
SOUTH FORK SHEN. RIVER  
TRIBUTARIES - CUB RUN  
ROCKINGHAM COUNTY, VIRGINIA
